INVESTIGATION OF SOLID CADMIUM EMBRITTLE-
MENT IN A-7 AIRCRAFT FAILED SHAFTS AND
HORN FRACTURE SURFACES

Vought Aeronautics Company

AFML-TR-72-249

This report covers an investigation to determine whether failures in A-7 aircraft horizontal tail actuator horn and shaft assemblies could be attributable to the solid cadmium embrittlement phenomenon.

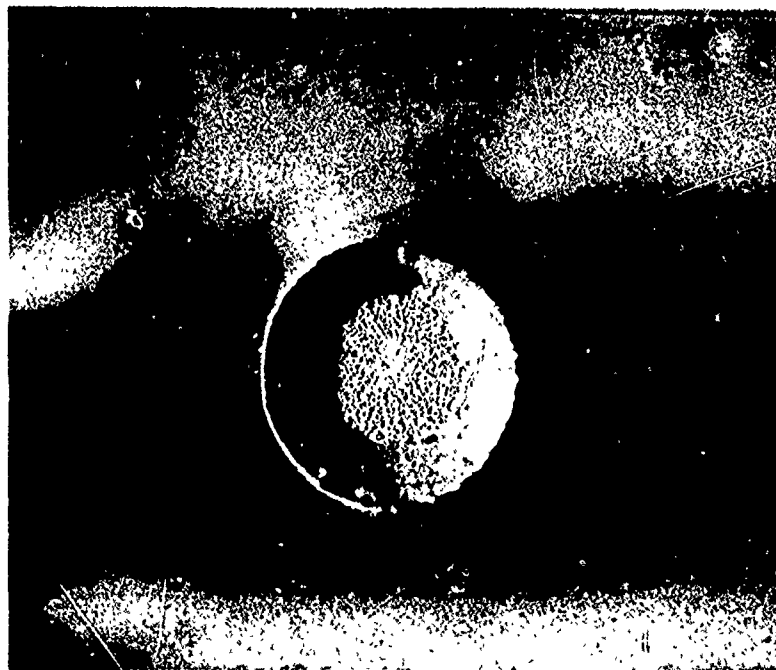
The fracture surfaces of the tensile specimens are shown in Figures 9 through 13. The control sample, Figure 9, consisted of a normal cup and cone fracture. Cracking first began at the center of the specimen and propagated radially. Figures 10 and 11 show low embrittlement cadmium samples. Cracking originated from the side of the specimens at one of several crescent

Figure 9. Fracture Surface on a Control Specimen Consisting of Normal Cup and Cone Fracture

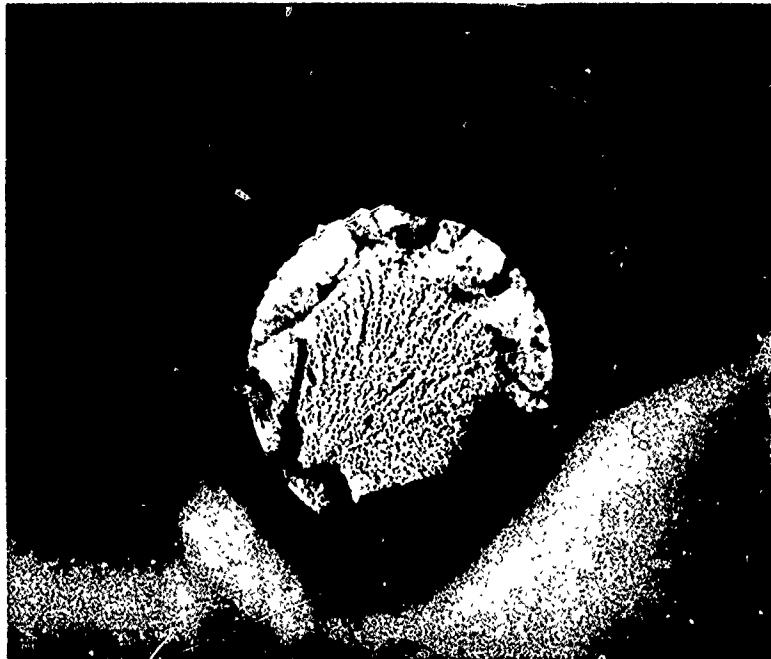
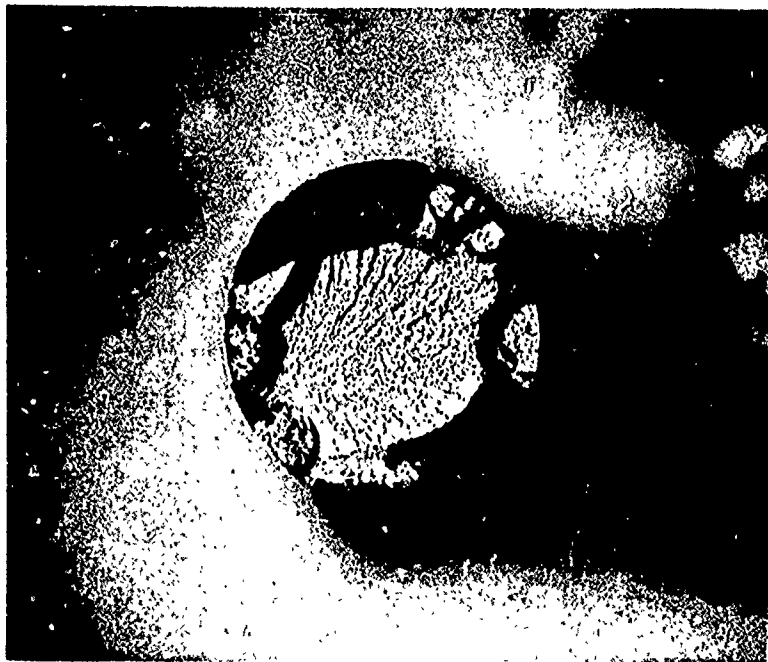
shaped regions on either sample. The crescents were characterized by a crystalline appearance and had a distinct yellow-gold coloration. Several secondary origins were observed on each fracture although the tensile fracture had propagated from a single origin. The vacuum cadmium specimens are shown in Figures 12 and 13. Unlike the low embrittlement cadmium samples, the vacuum cadmium specimens exhibited only one origin on each specimen. Thus it would appear that the low embrittlement cadmium plate was more prone to induce embrittlement than the vacuum cadmium plate. Other variations which were apparent were that the origins on the vacuum cadmium specimens were irregularly shaped and more darkly colored as compared to the low embrittlement cadmium specimens. In all cases however, the origin cracks were located only where the pressure had been applied.

Figure 10. Fracture Surface of Ti-Cad Specimen No. 1.

Figure 11. Fracture Surface of Ti-Cad Specimen No. 2.

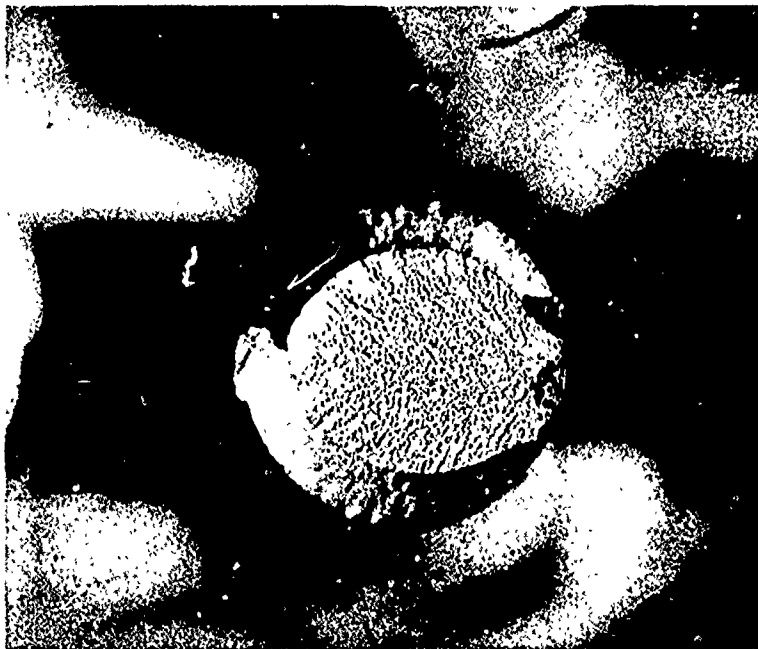
Figure 12. Fracture Surface of Vac-Cad Specimen No. 1.

Figure 13. Fracture Surface of Vac-Cad Specimen No. 2.

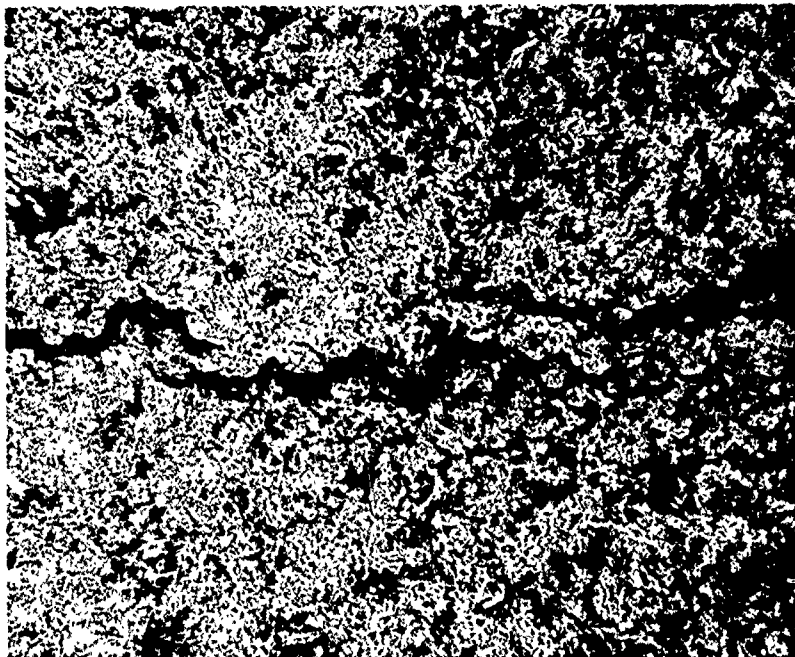
Figure 16. Perpendicular Crack Depicted in Figure 14 Showing Predominantly Intragranular Mode with Possible Cleavage.

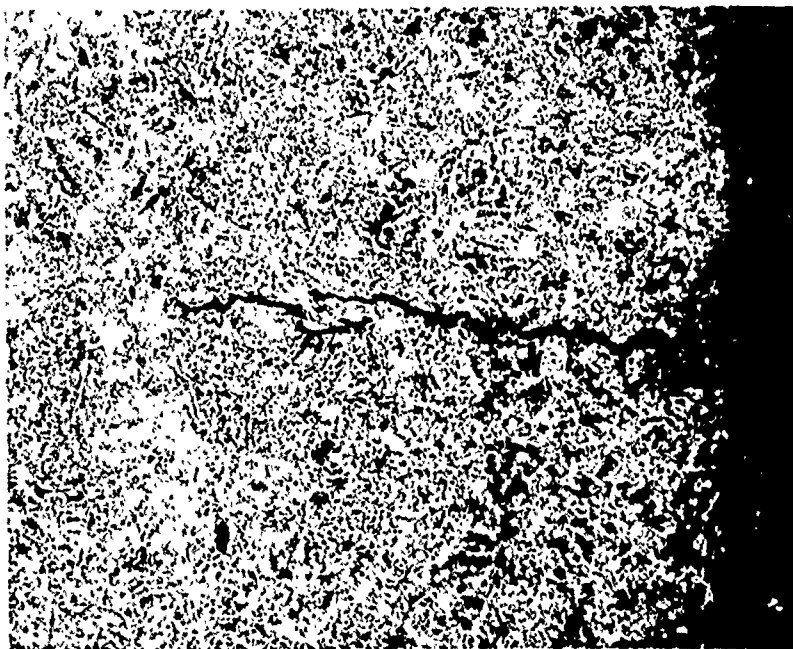
Figure 17. Additional Crack Parallel to Origin in Figure 14. Crack Initiated at the CD-Steel Interface and Appeared to be Both Intergranular and Cleavage Modes.

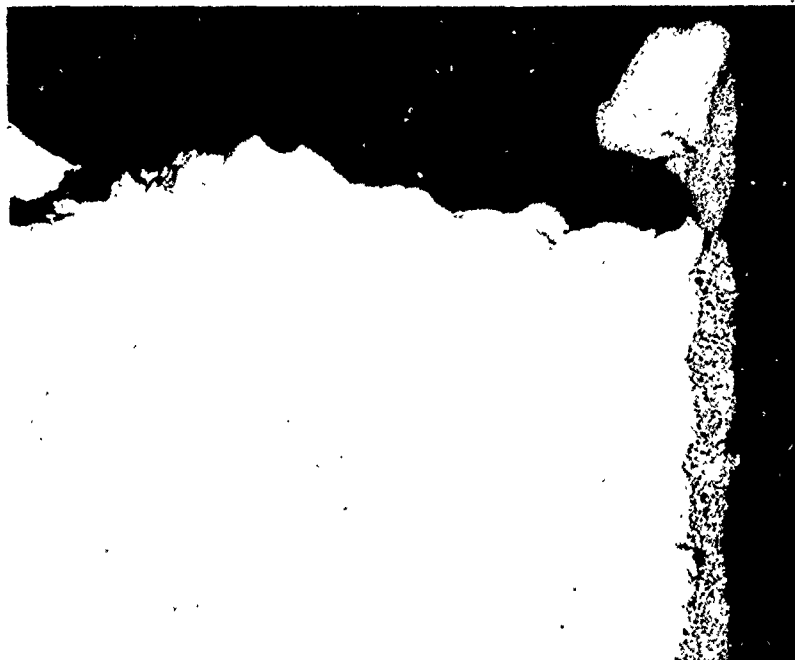
Figure 18. Cross Section of Vac-Cad Induced Failure Showing Origin at Top Right and Some Intragranular Cracking at the Fracture Surface. Unetched.

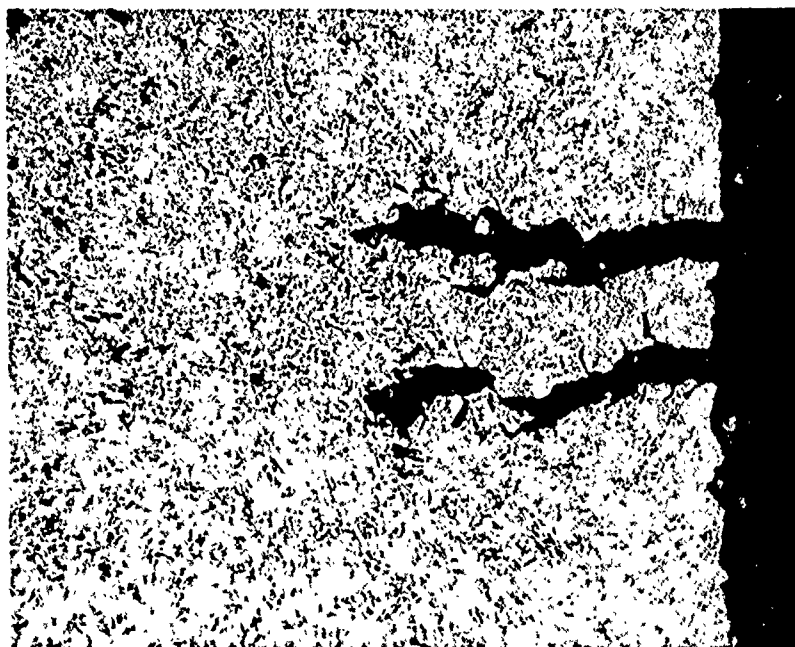
Figure 19. Parallel Cracks Adjacent to Origin in Figure 18. Intergranular Branching Can Be Seen Propagating from Cracks Opened Up During Tensile Loading. Nital Etch.

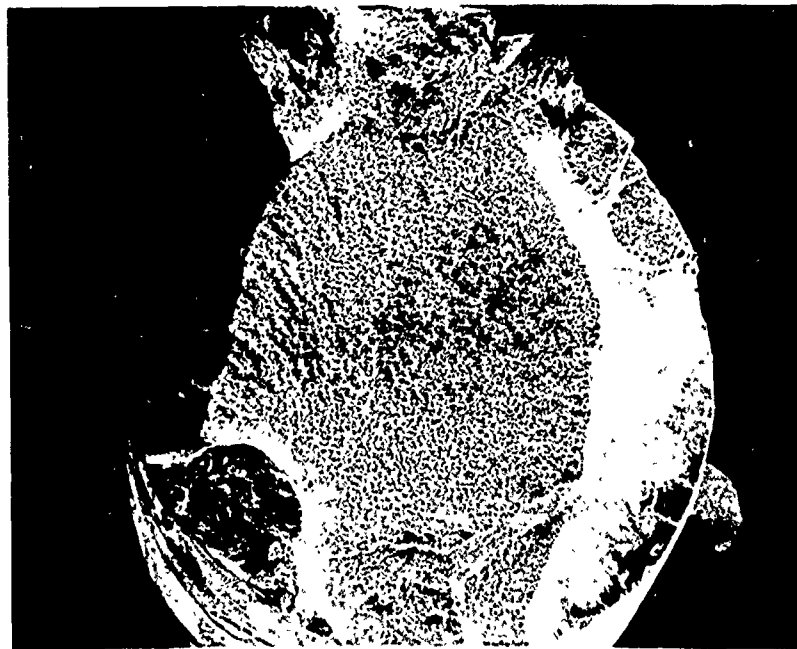
Electron microscopy revealed several features not apparent at lower magnifications. Figures 20 and 21 show one of the low embrittlement cadmium fractures in detail. Figures 22 and 23 are comparable pictures of a vacuum cadmium sample. In the lower magnification shots, 20 and 22, it is apparent that cracking originated at the steel-cadmium interface and progressed into the steel. The higher magnifications, Figures 21 and 23, show that the origins are somewhat different. The low embrittlement cadmium appears to have generally followed a single plane; the vacuum cadmium, however, tended to branch into several cracks.

Figure 20. Photomicrograph Showing the Fracture Surface of Ti-Cad Specimen No. 2 - Scanning Electron Micrograph

Figure 21. Photomicrograph Showing Details of One of the Origin Cracks on Ti-Cad Specimen No. 2 - Scanning Electron Micrograph

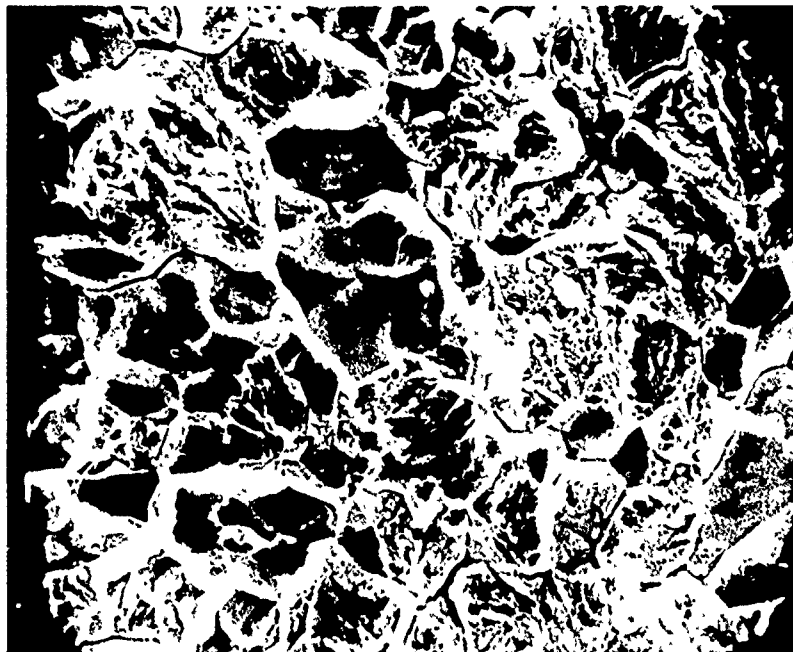
(Figure 24) was comprised completely of cleavage fracture. The vacuum cadmium sample (Figure 25) consisted of a mixture of intergranular and cleavage fractures. Near the middle of the origins, the difference disappeared and the topography became mixed cleavage and intergranular cracking as demonstrated in Figures 26 and 27. The topography remained the same until the onset of catastrophic failure. Figures 28 and 29 show the fracture topography adjacent to the rapid fracture zone. In both cases, the rapid fracture zone was comprised of dimpled rupture as illustrated in Figure 30.

Figure 26. Fracture Appearance Near Mid-origin on Ti-Cad Specimen No. 2 - Scanning Electron Micrographs

Figure 27. Fracture Appearance Near Mid-origin on Vac-Cad Specimen No. 2- Scanning Electron Micrograph

Figure 28. Fracture Appearance at the Onset of Fast Fracture in Ti-Cad Specimen No. 2 - Scanning Electron Micrograph

Figure 29. Fracture Appearance at the Onset of Rapid Fracture in Vac-Cad Specimen No. 2. Scanning Electron Micrograph

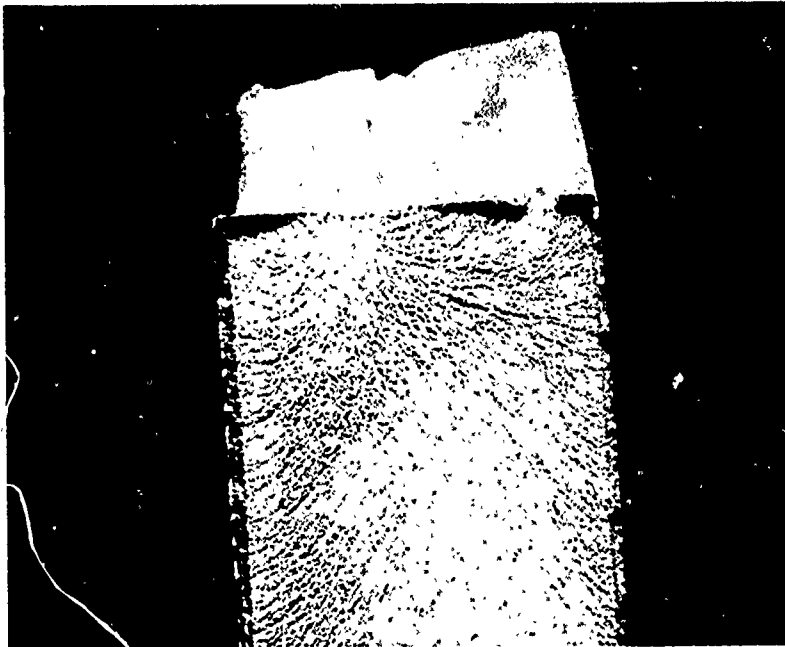
Figure 54. Fracture Appearance Near Mid-origin on Fracture from A-7D-8.
Transmission Electron Micrograph

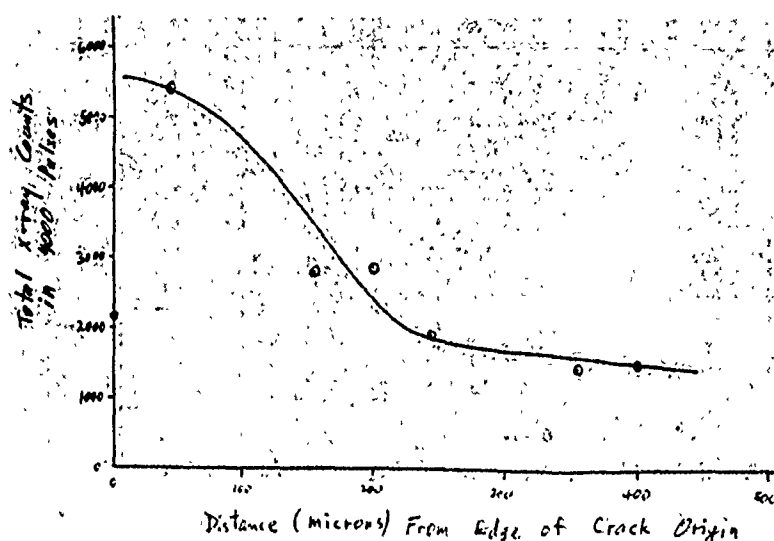
Figure 69 is a cadmium distribution map of the same area. Figure 70 shows the cadmium concentration profile along this surface measured while moving the electron beam down the hatched vertical line in the center of the previous photographs. Both indicate there is some cadmium on the fracture surface, but they do not indicate any concentration gradient from the edge inward. However, cadmium point counts, shown plotted in Figure 71 show that such a gradient is present.

Figure 71. Cadmium Concentration Gradient as Revealed by Point Counts Along Fracture Surface Showing in from Cadmium-plated Edge.

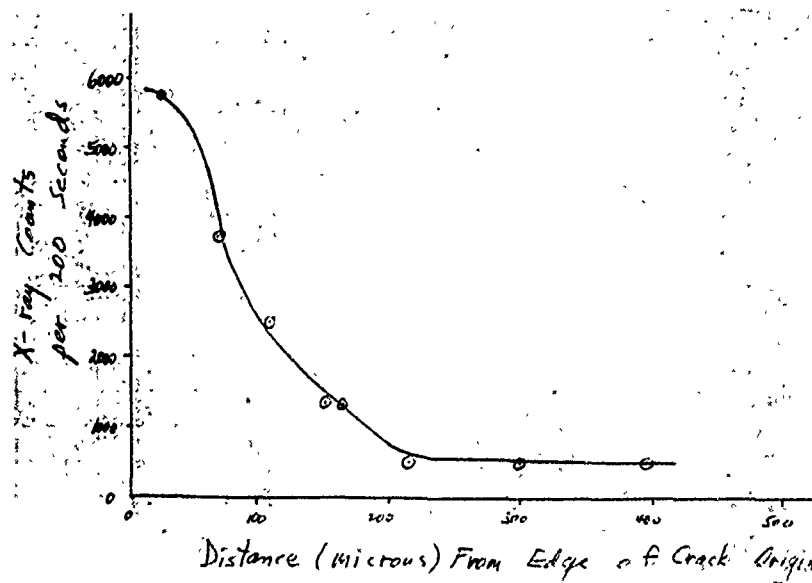
Figure 72 is the backscattered and secondary electron scan of a portion of the origin of the same induced cadmium-embrittled failure. Figure 73 shows cadmium distribution over the same surface area. That the dark irregular area near the upper right corner of Figure 72 is the cadmium plate is clearly revealed in Figure 73. In addition, a gradient in cadmium concentration can be seen, decreasing with distance from the plate inward. This gradient is confirmed by the plot of point counts, with distance moved inward from the plated edge shown as Figure 74.

Figure 74. Cadmium Concentration Gradient as Revealed by Point Counts Along Fracture Surface Moving in from Cadmium-plated Edge.

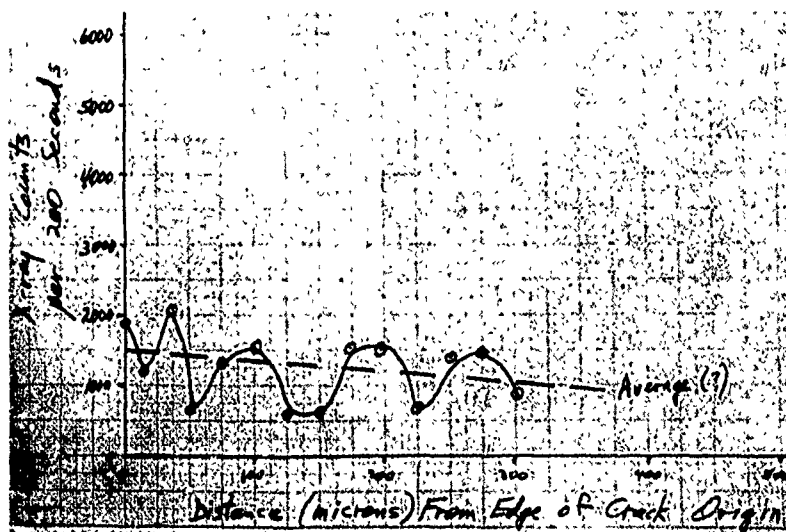
Figure 79 shows the backscattered and secondary electron image of the A7B-121 fracture origin. The cadmium distribution map, shown in Figure 80, indicates scattered pockets of cadmium distributed over the fracture surface. There is no evidence of a concentration gradient, however. Point counts for this area are shown in Figure 81. No gradient is present. The count rate is sporadic, but uniformly low.

Figure 81. Cadmium Concentration Gradient as revealed by Point Counts Along Fracture Surface Moving in from Cadmium-plated Edge at Right.

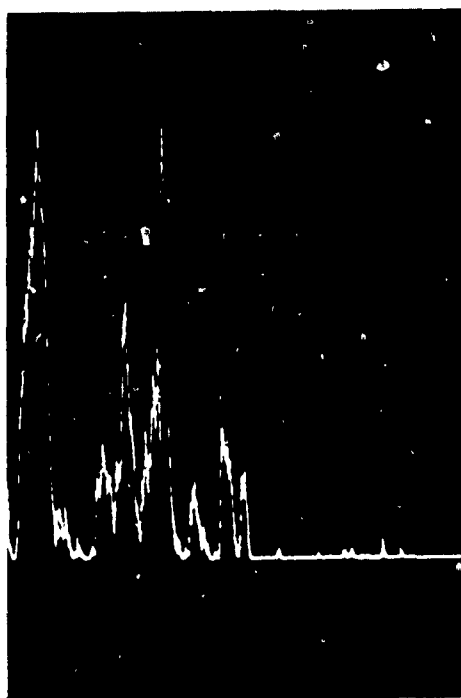
Figures 91, 92, and 93 show similar results for this in-service fracture.

Figure 91. Backscattered Electron Image of Origin, Shaft from A-7D-8. ARL Probe.

Figure 92. Cadmium X-ray Distribution Map of Same Area Shown in Figure 91. ARL Probe.

Figure 93. Cadmium Concentration Profile Measured Along the Vertical Centerline Shown in Figure 91. ARL Probe

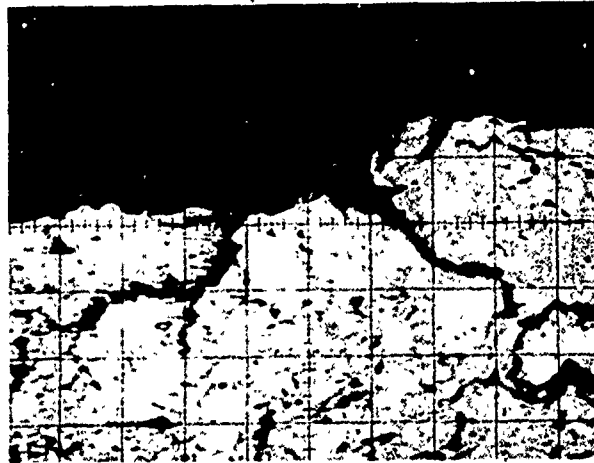
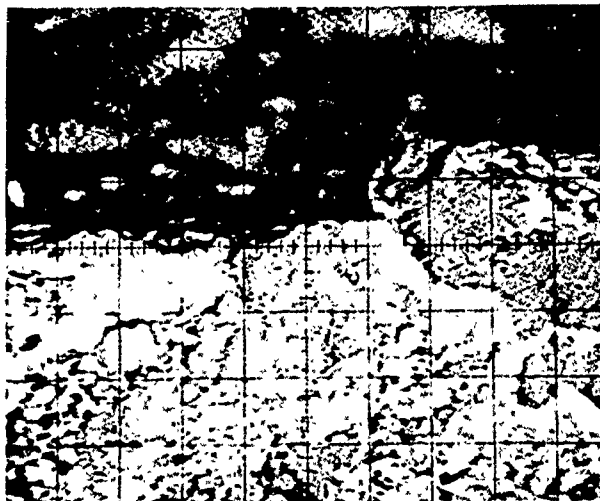
Figure 94 shows the backscattered electron image for the origin of this fracture. For comparative purposes, the secondary electron image is shown in Figure 95 and the specimen current image in Figure 96 for the same surface area. These furnish a good example of the strong points in each of the three types of presentation. The backscattered image emphasizes the system of deep cracks associated with this fracture origin. The secondary image gives a good general picture of surface topology, while the specimen current image hints at elemental segregation on various parts of the surface area under consideration.

Figure 94. Backscattered Electron Image of Origin, Shaft from A-7B-181.
ARL Probe.

Figure 95. Secondary Electron Image of Origin, Shaft from A-7B-181.
ARL Probe.

Figure 96. Specimen Current Image of Origin, Shaft from A-7B-181.
ARL Probe.

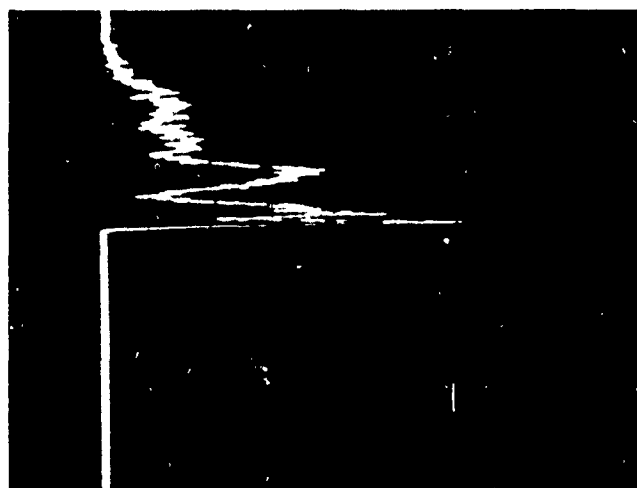
Figure 99 shows the backscattered electron image of the origin of the fractured UHT horn from A7B-183. Corresponding cadmium distribution and profile for this fracture area are shown in Figures 100 and 101. As on the shaft failures, no cadmium gradient was found.

Figure 99. Backscattered Electron Image of Origin, UHT Horn from A-7B-183. ARL Probe.

Figure 100. Cadmium X-ray Distribution Map of Origin, UHT Horn from A-7B-183.
ARL Probe

Figure 101. Cadmium Concentration Profile Measured Down the Vertical
Hatched Line in Figure 99.
